# Manhole Inspection Summary

Manhole # S15I\_\_019MH

Insp Date: **2/26/08 11:10 AM**

**Location** Address: **44 franklintown rd**

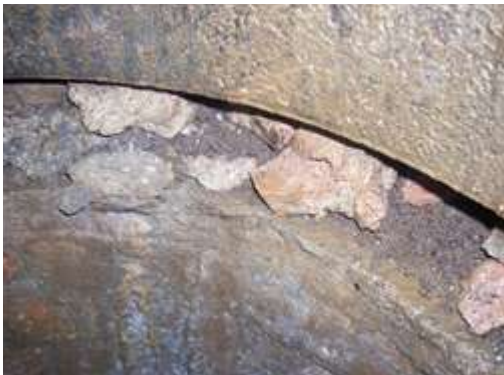
Defect 2

deteriorated chimney

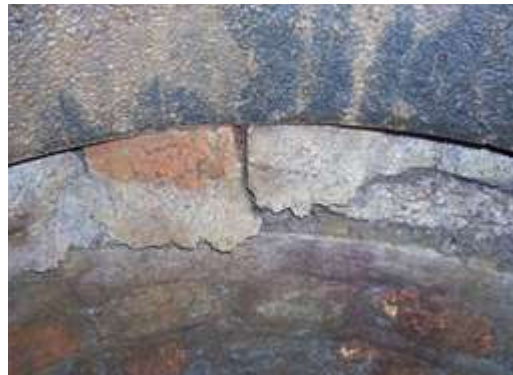
Defect 1

Condition: ☐ Sound ☒ **Cracked** ☐ Root Intrusion ☐ Loose Brick ☒ **Deteriorated**

cracked chimney

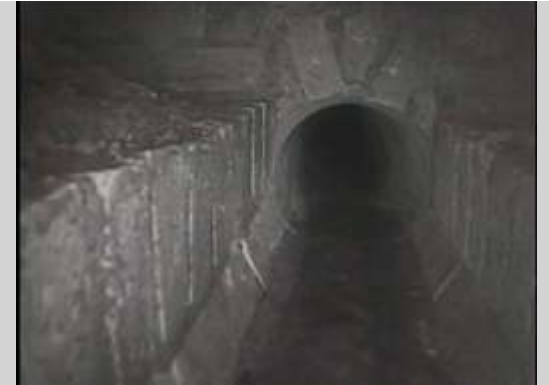
12 O'Clock Outflow

8 in. Circular Gravity Sewer  
Pipe Out @ 12 O'Clock

Pipe Height: **8.4** (in.) Rod and Bar (Angled)  
Pipe Material: **Clay** ☐ Pipe Lined  
Invert Depth: **15.33** (ft.) Flow Characteristics: **Slow**  
Deposits: ☒ None ☐ Mud ☐ Sludge ☐ Debris ☐ Grease  
Silt Depth: **0** (in.) Deposits Extent:  
Infiltration: **None** Pipe Seal Cond: **Sound**

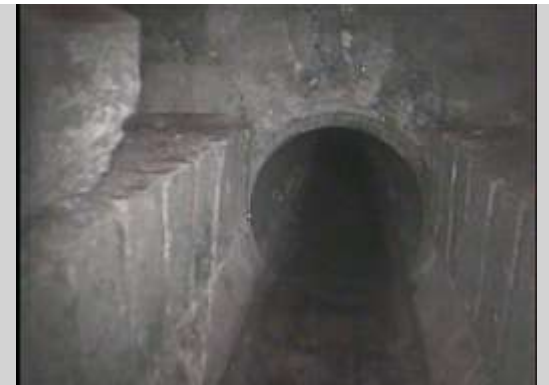
6 O'Clock Inflow

8 in. Circular Gravity Sewer  
Pipe In @ 6 O'Clock

Pipe Height: **8.4** (in.) Rod and Bar (Angled)  
Pipe Material: **Clay** ☐ Pipe Lined  
Invert Depth: **15.28** (ft.) Flow Characteristics: **Slow**  
Deposits: ☒ None ☐ Mud ☐ Sludge ☐ Debris ☐ Grease  
Silt Depth: **0** (in.) Deposits Extent:  
Infiltration: **None** Pipe Seal Cond: **Sound**
